Service Publication for the Kodak Ektachem DTSC MODULE

Kodak Ektachem DTSC MODULE General Information Section 1

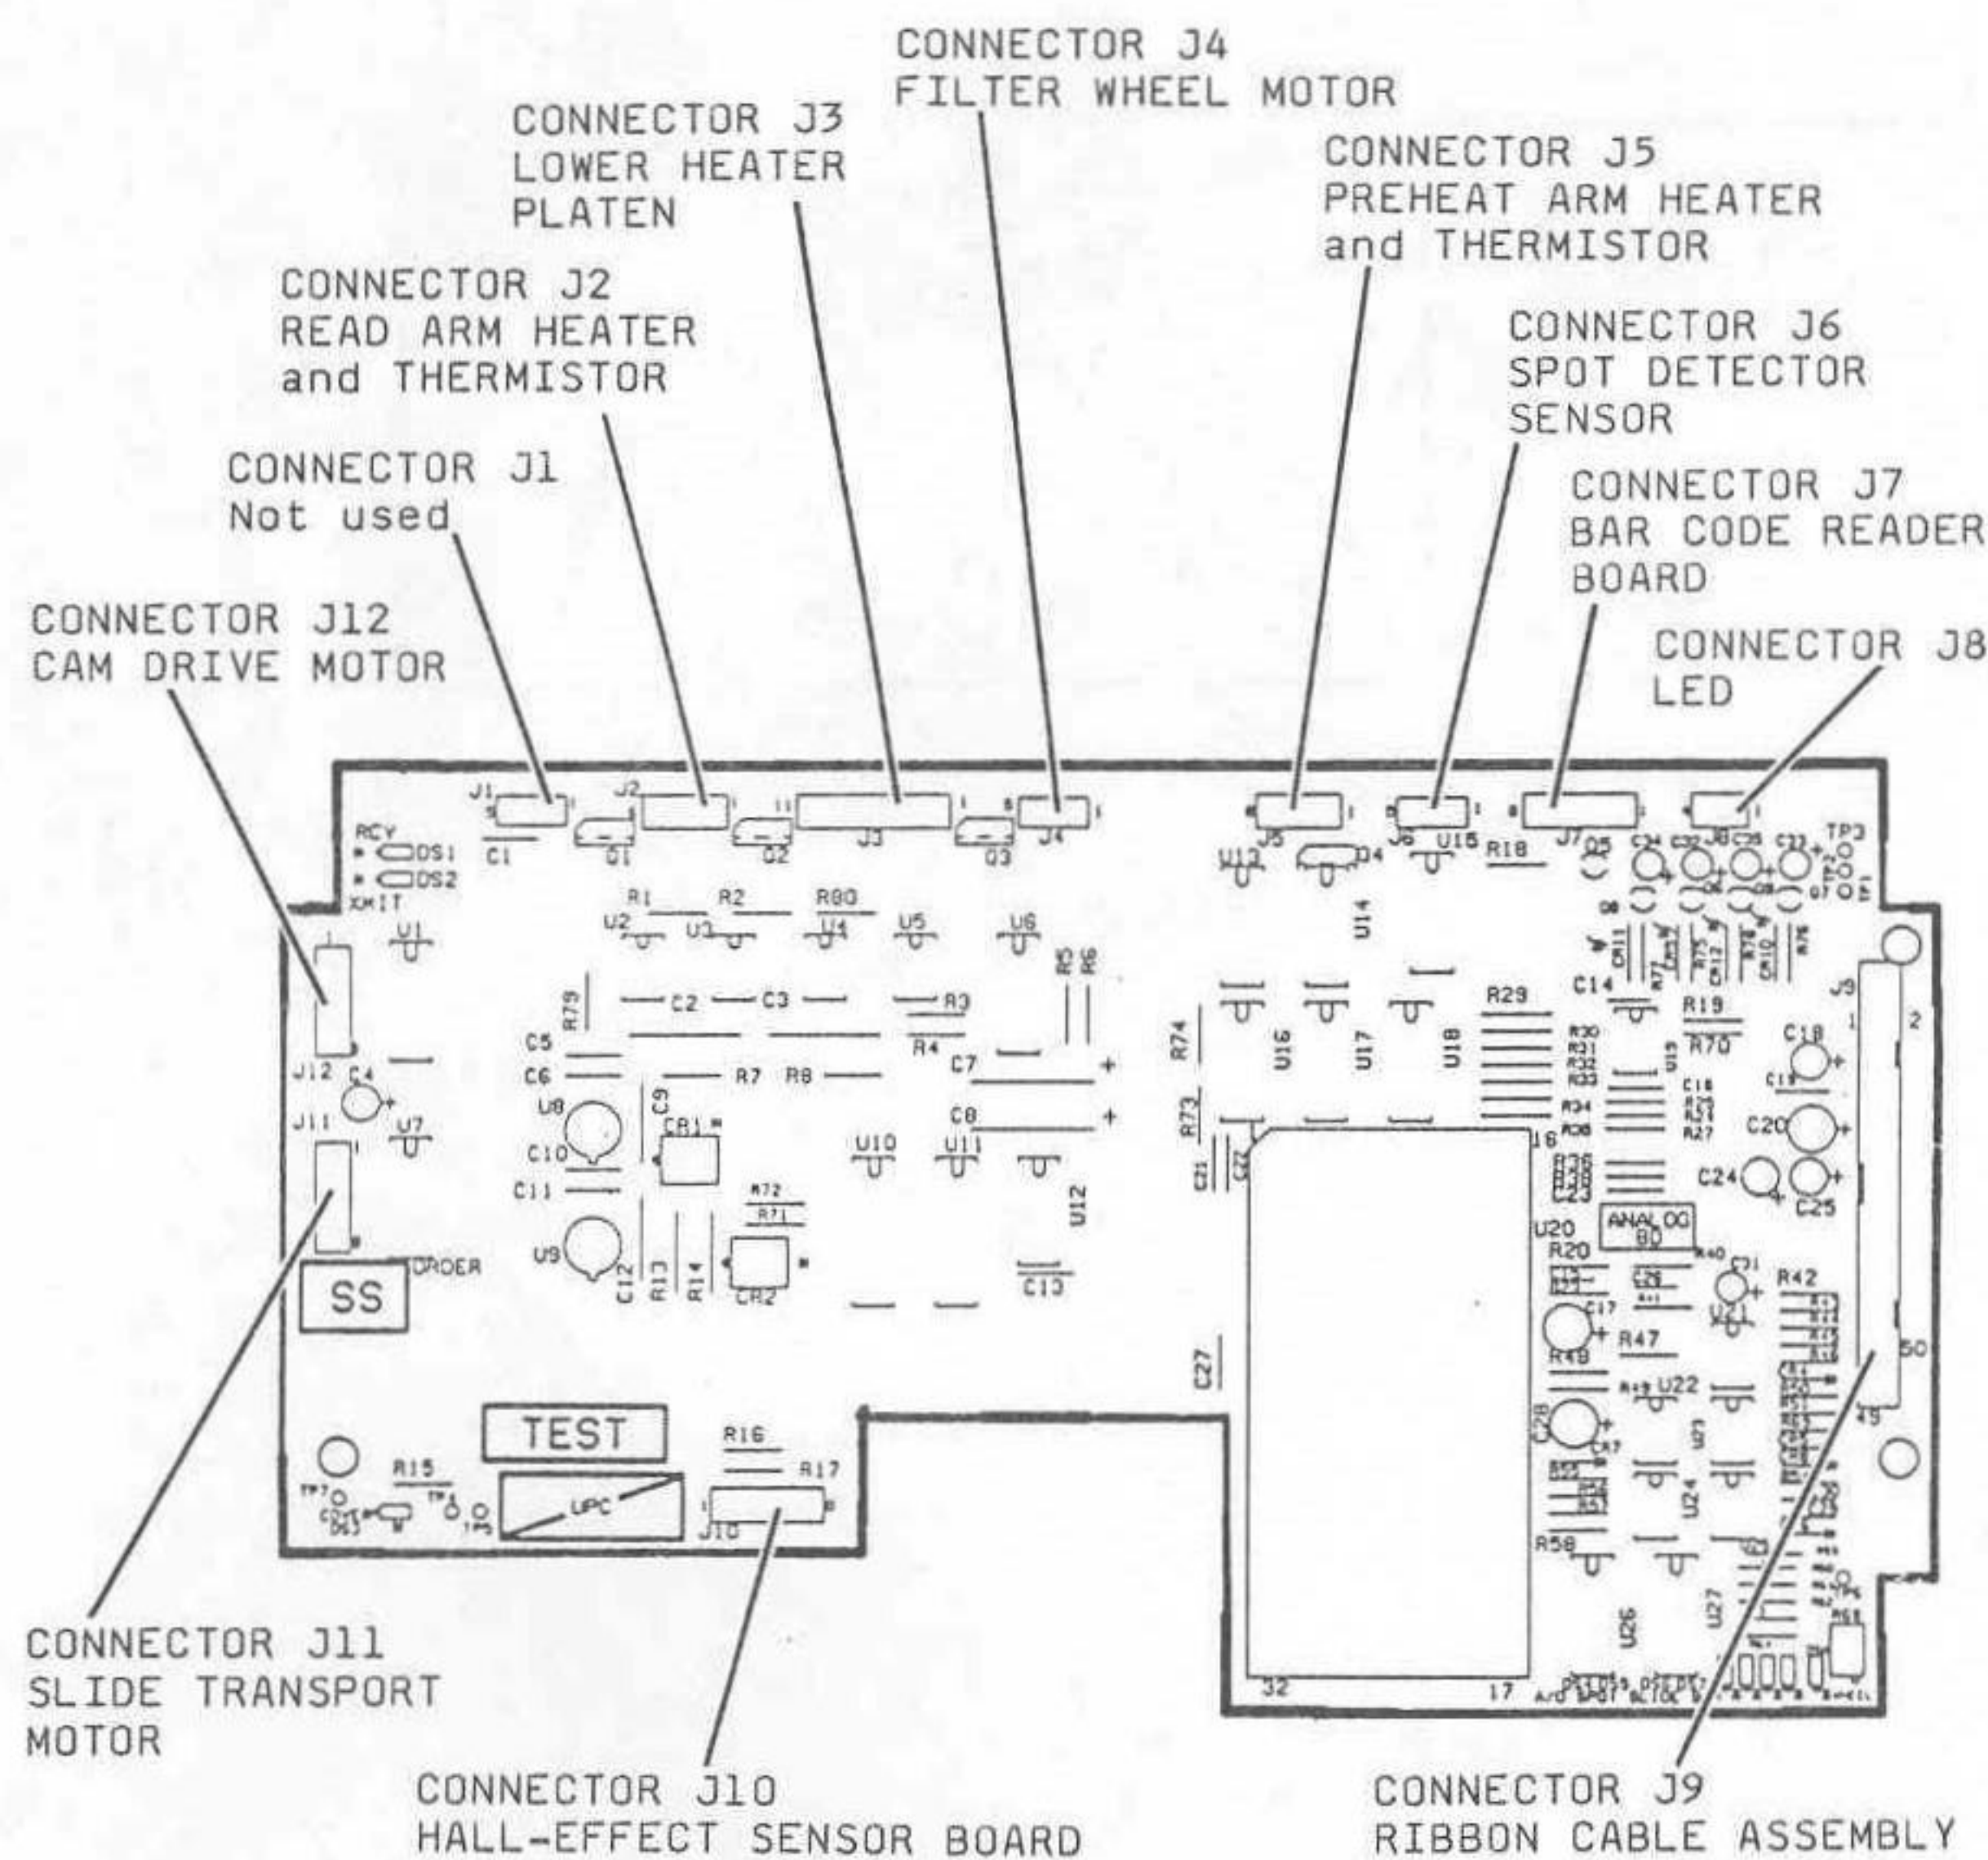
Figure 6 Position of the CONNECTORS on the ANALOG BOARD

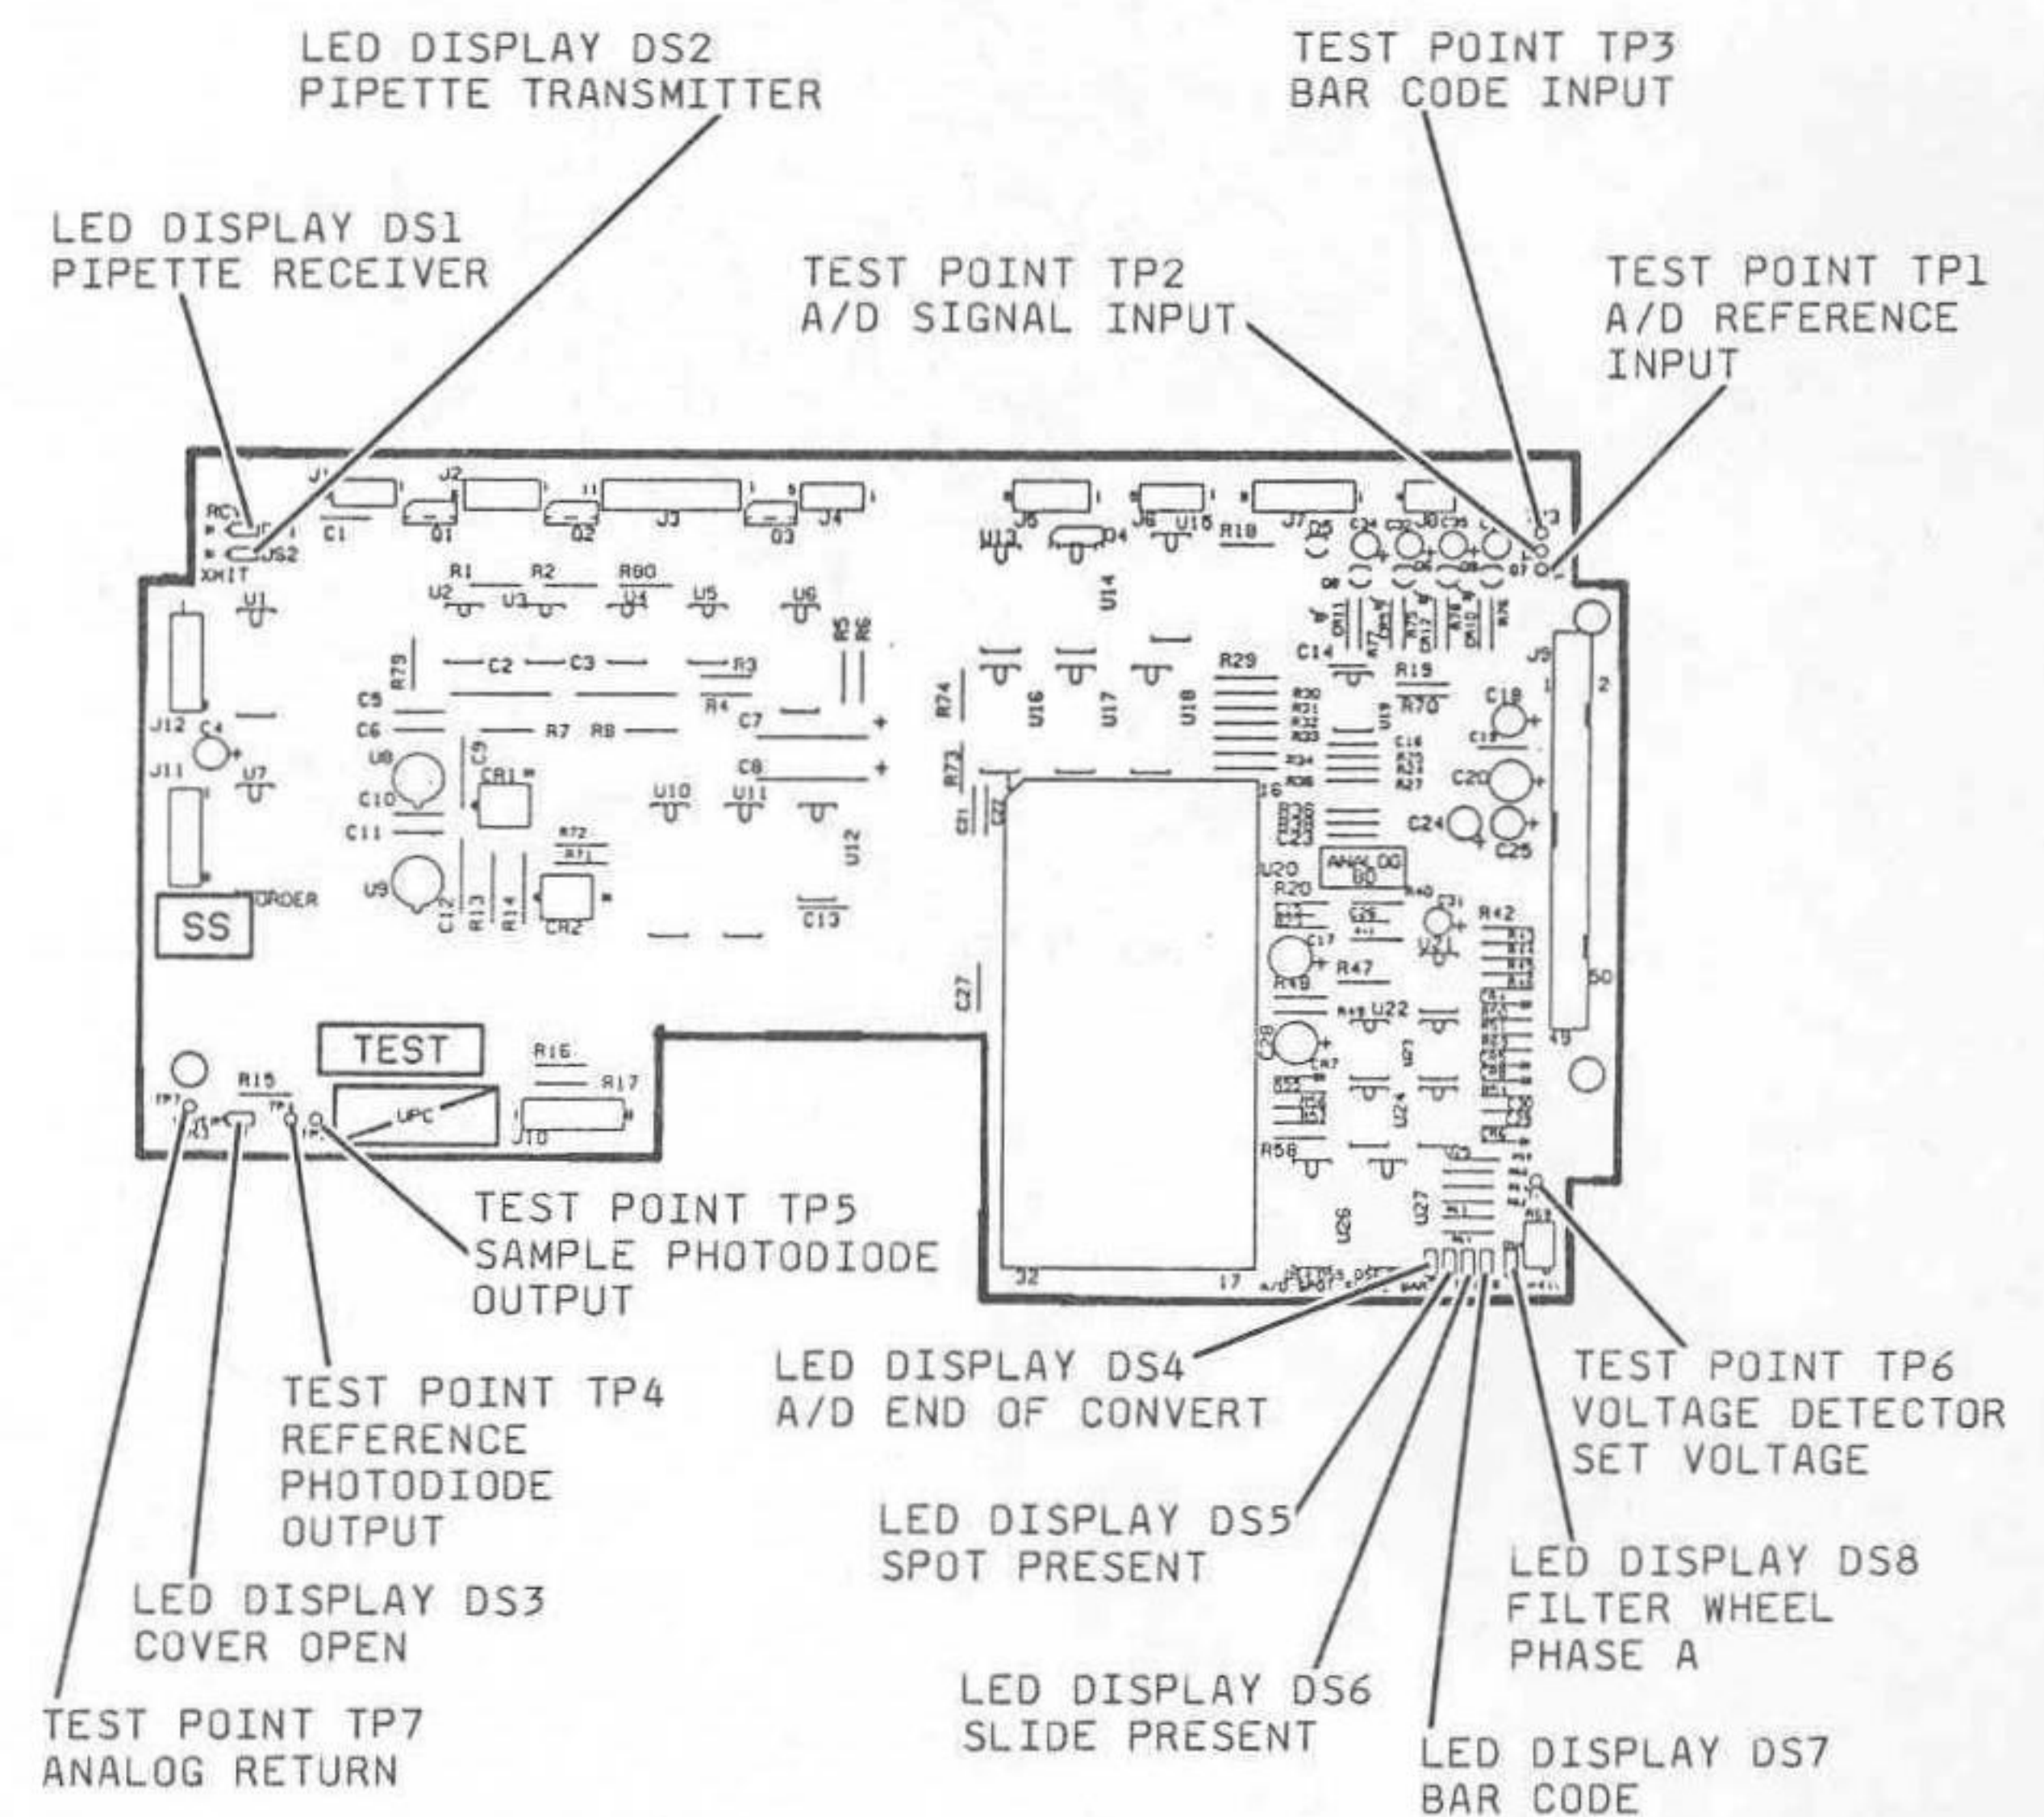
Figure 7 Position of the LED DISPLAYS and TEST POINTS on the ANALOG BOARD

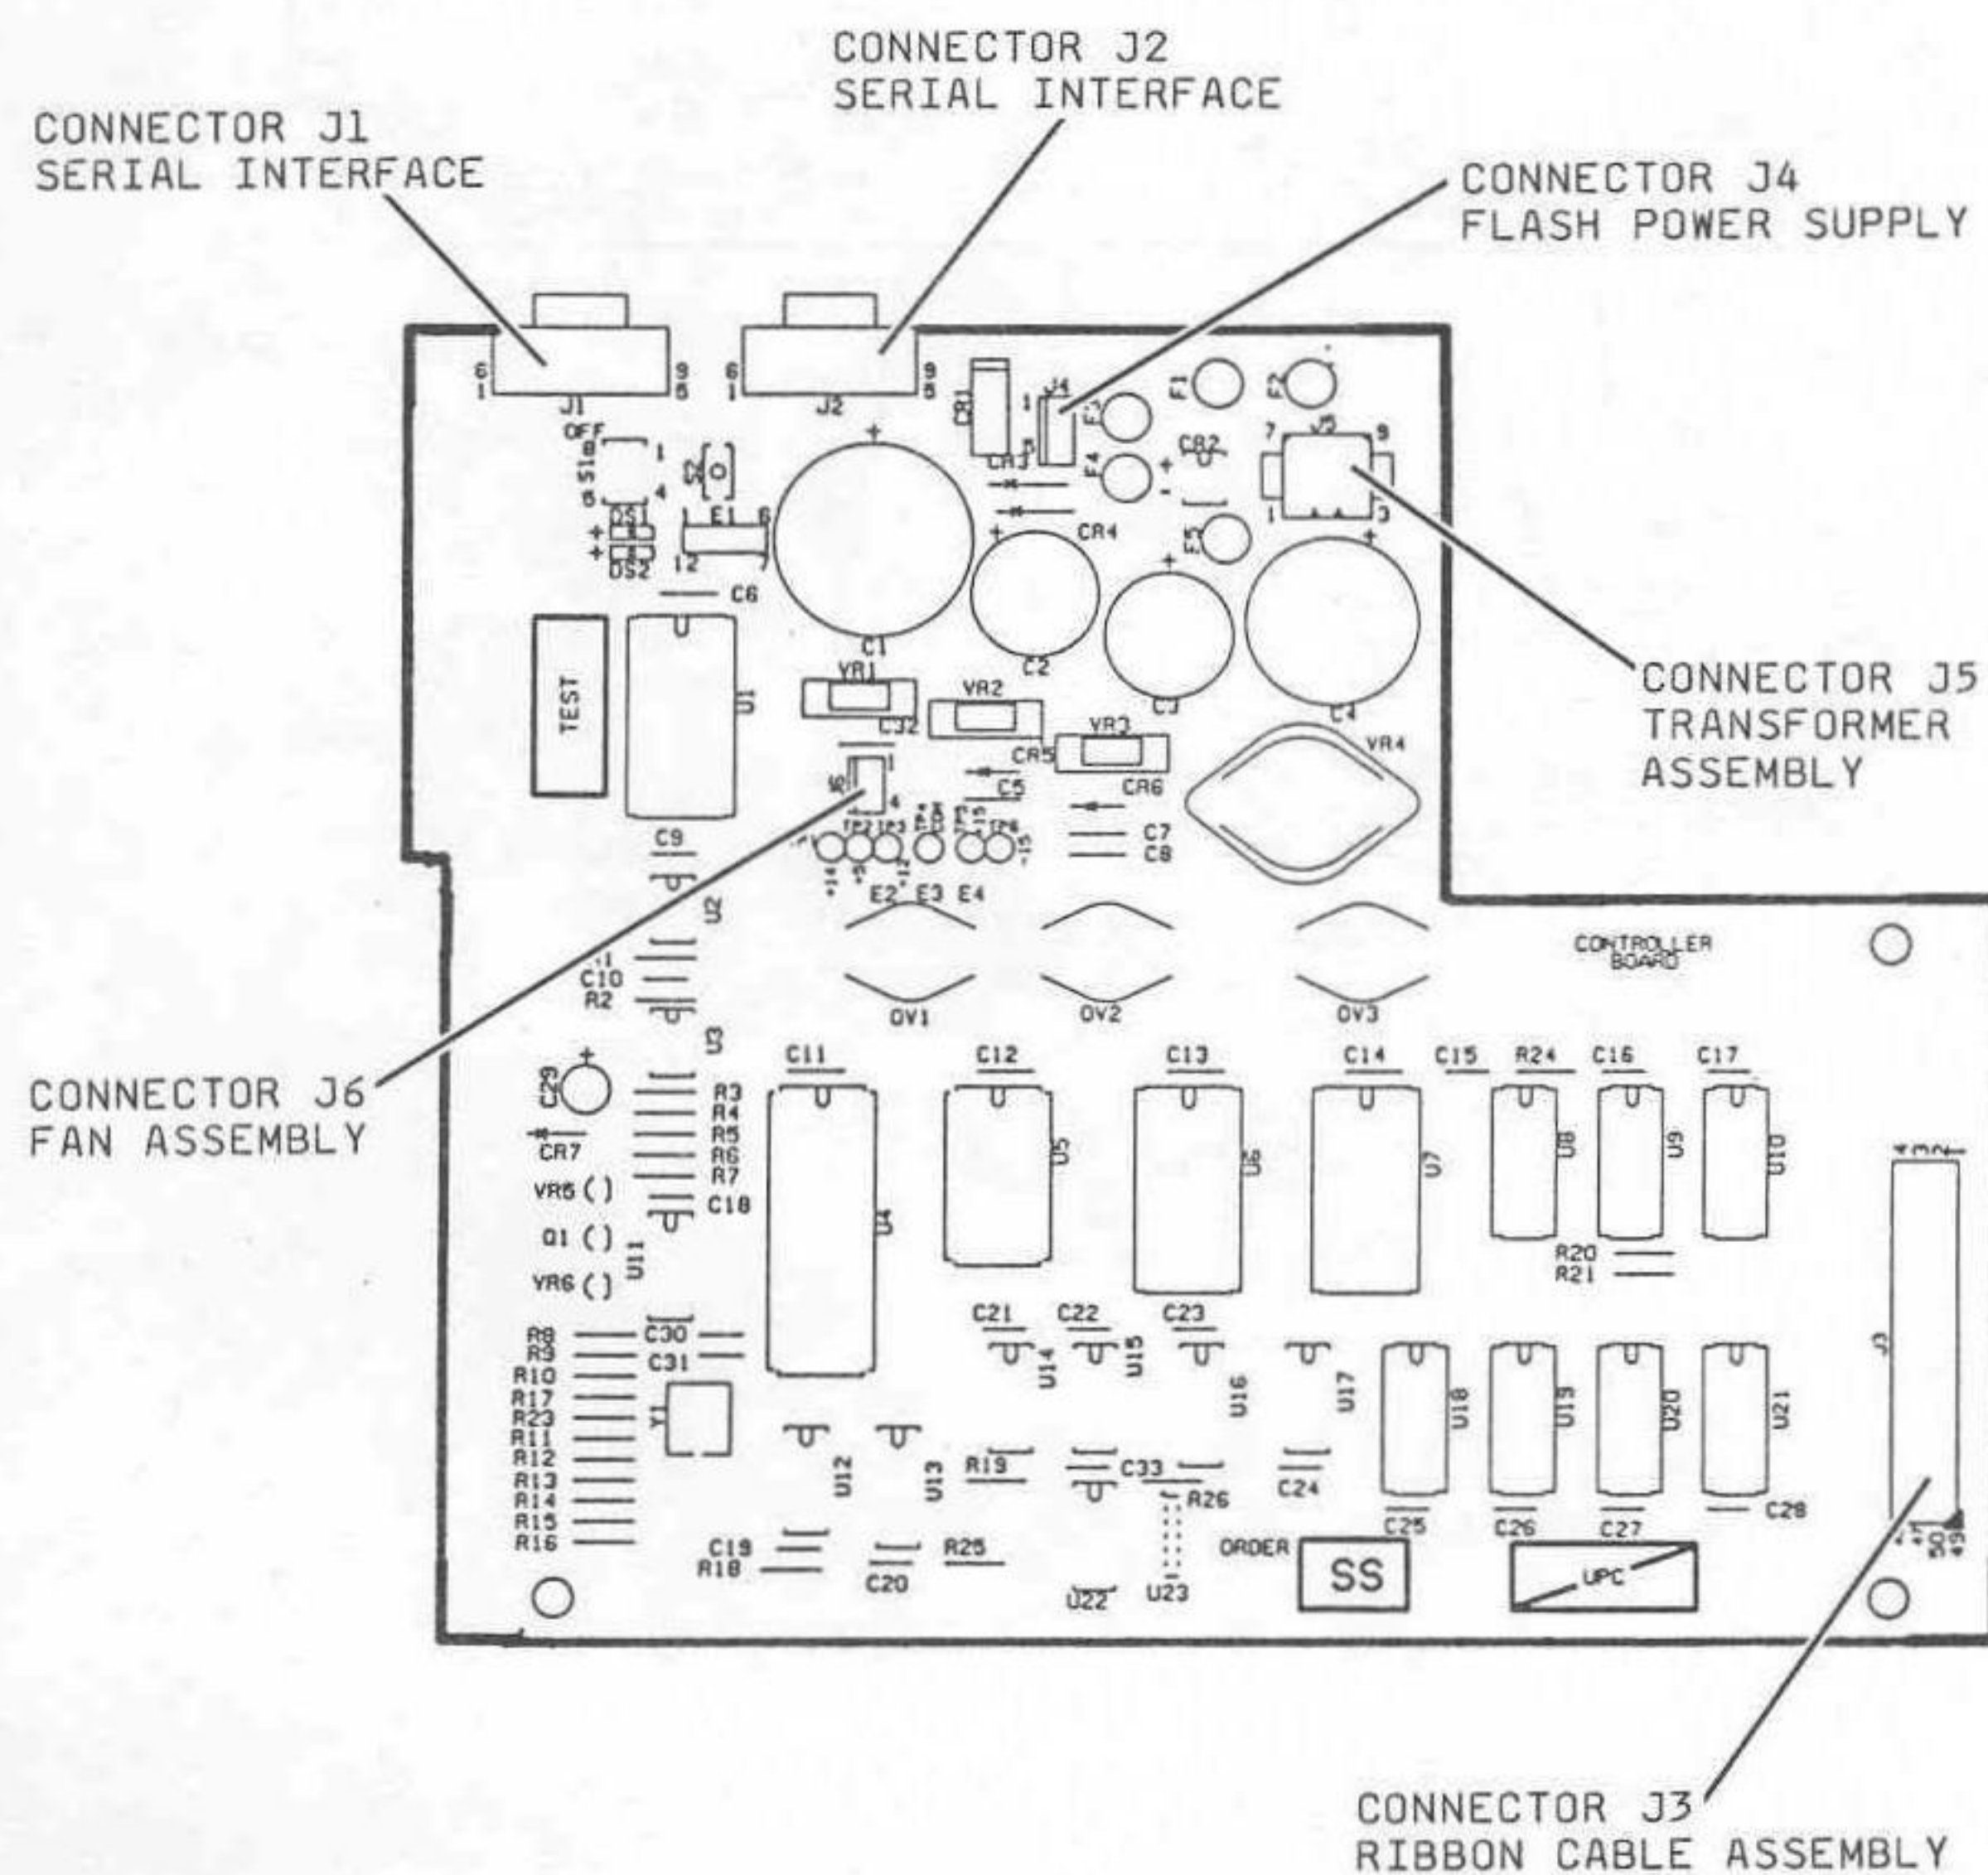
Figure 8 Position of the CONNECTORS on the CONTROLLER BOARD

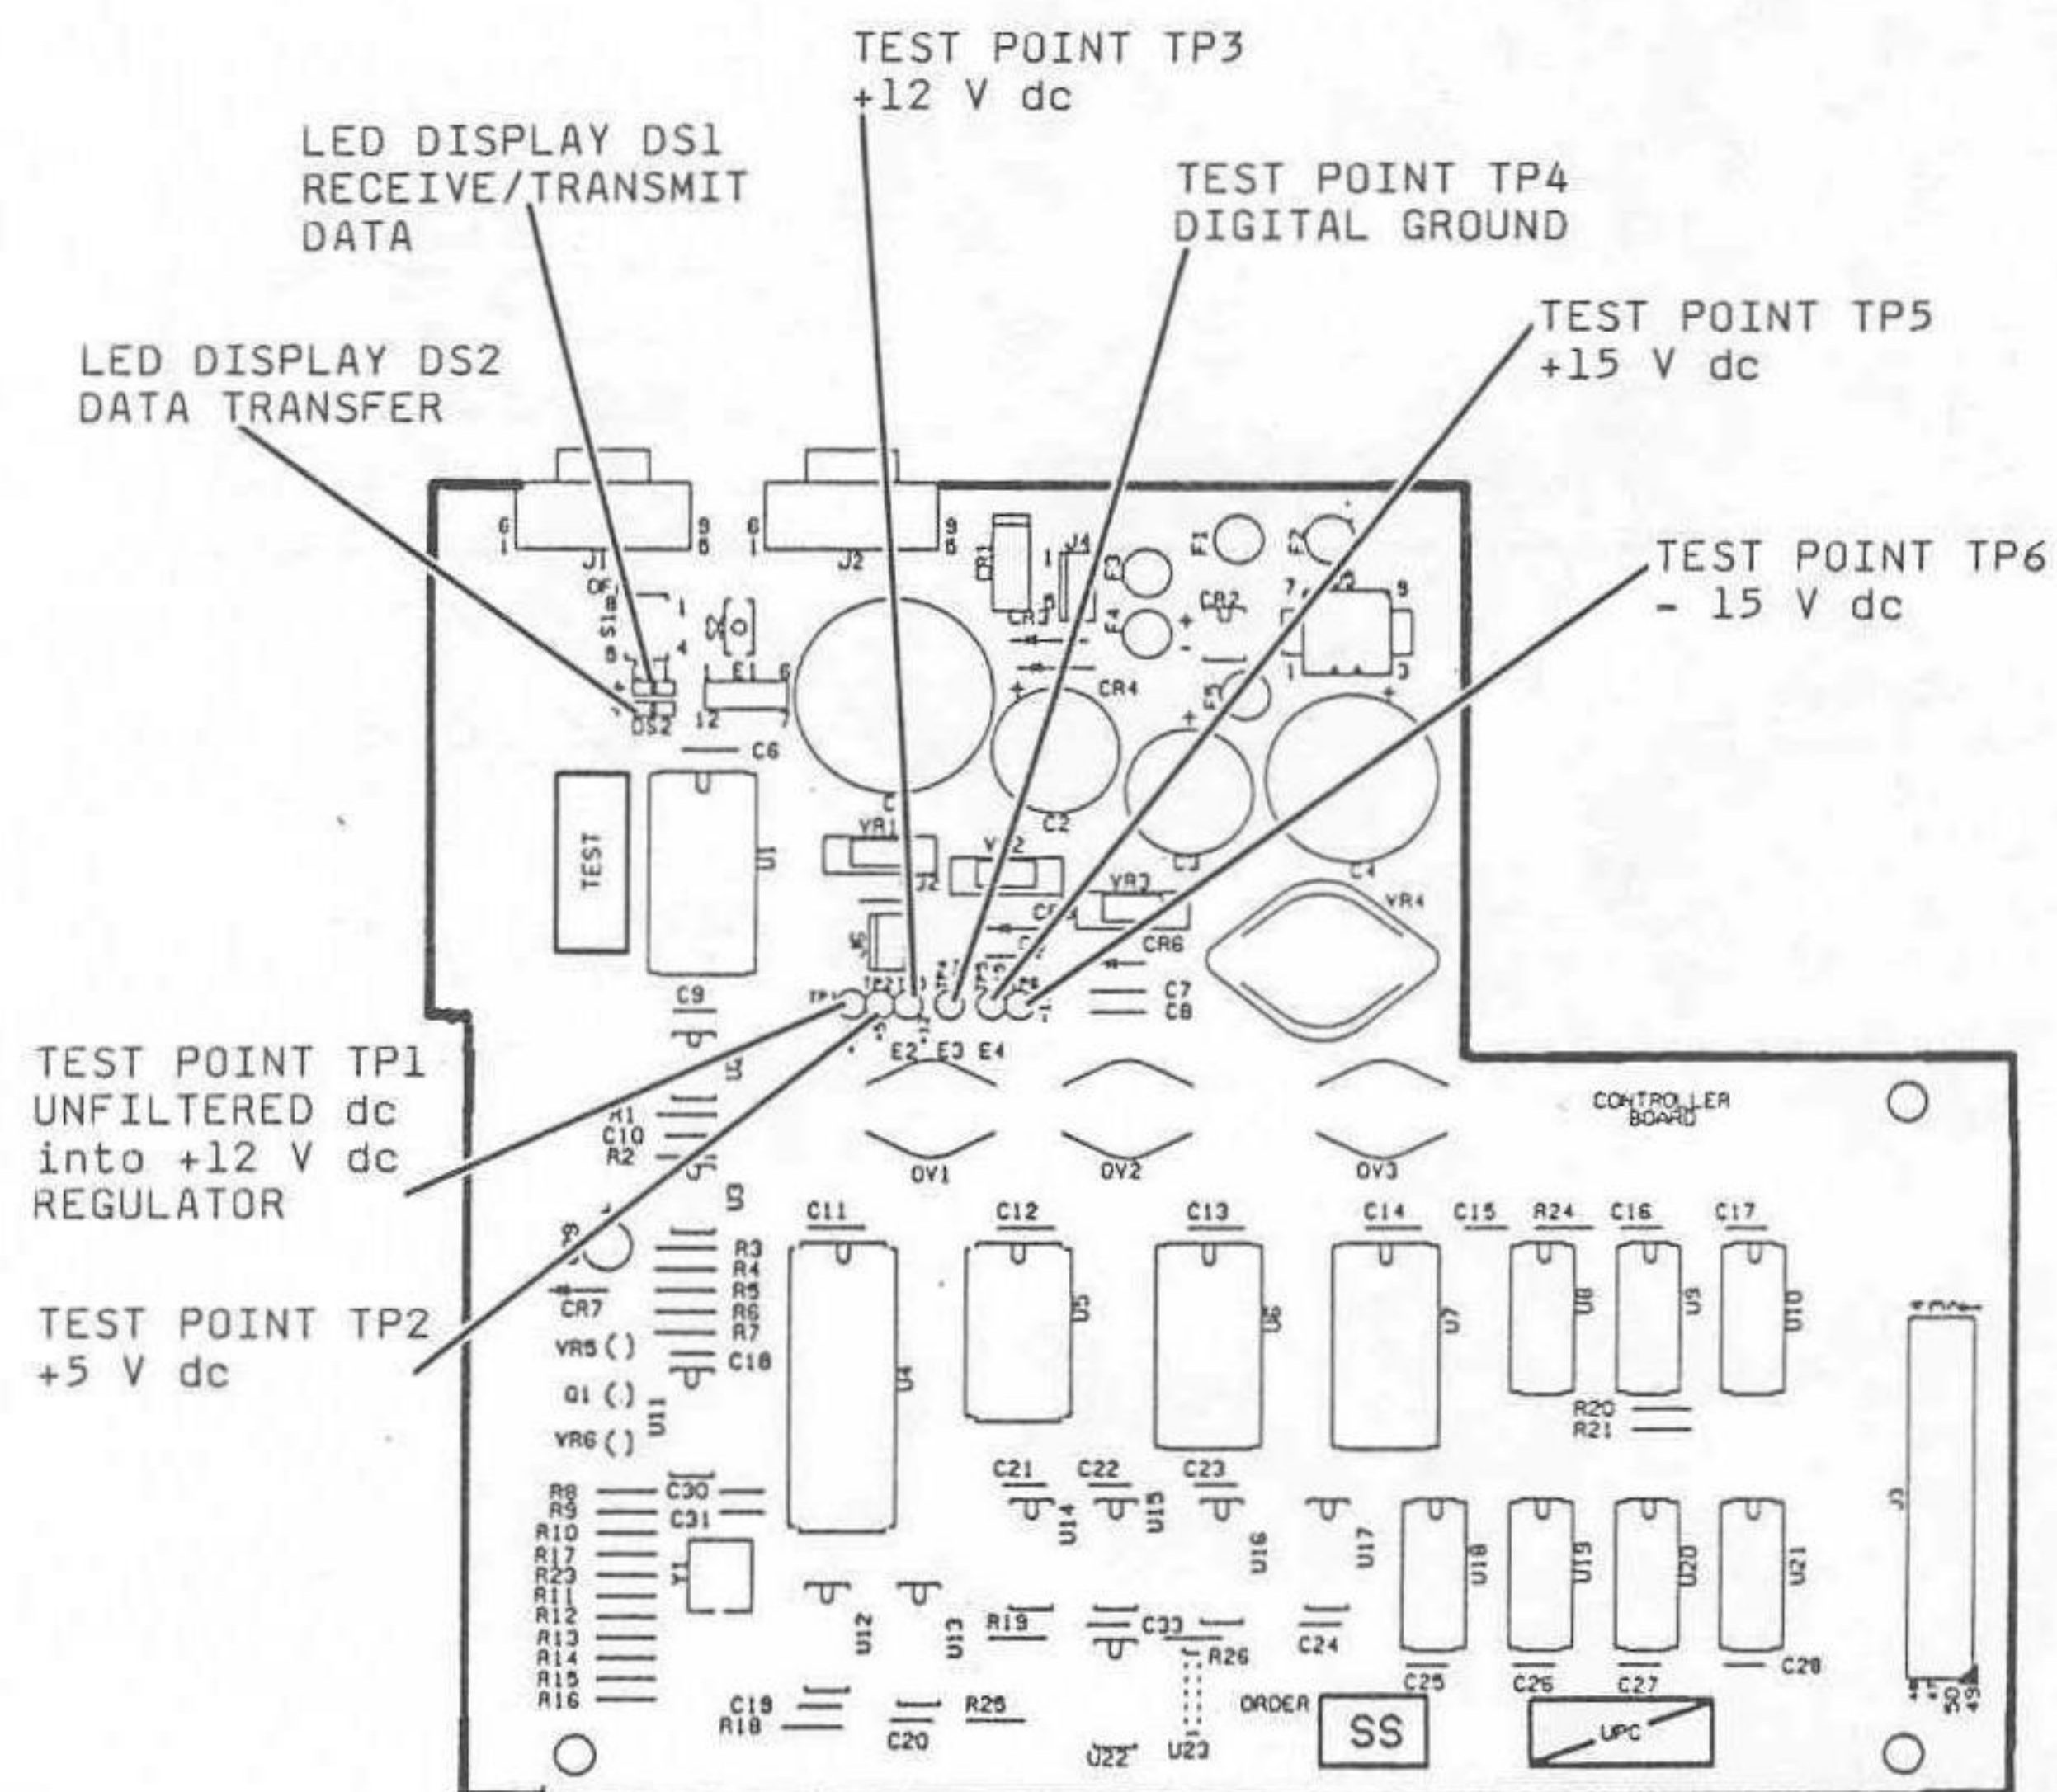
Figure 9 Position of the LED DISPLAYS and TEST POINTS on the CONTROLLER BOARD

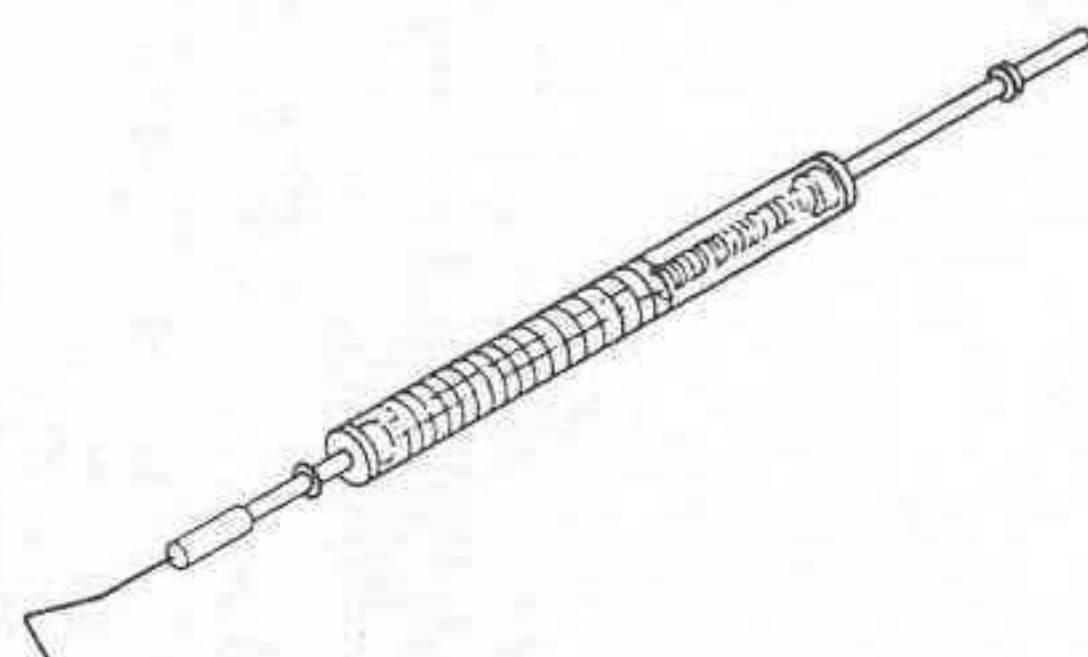
PUSH-PULL SCALE TL-1079

A flexible plastic SLIDE TRANSPORT BELT extends from the DRIVER PULLEY connected to the SLIDE TRANSPORT MOTOR to the IDLER PULLEY near the Pickup Station. The tension of the SLIDE TRANSPORT BELT must be adjusted for correct operation. A special tool, the PUSH-PULL SCALE TL-1079, is used to check the adjustment.

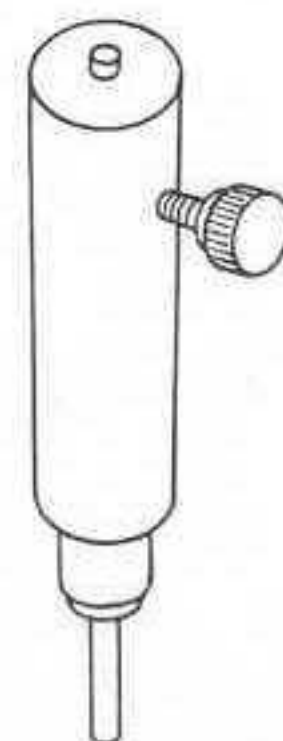
TIP HEIGHT ADJUSTMENT
GAUGE TL-3446

The TIP HEIGHT ADJUSTMENT GAUGE TL-3446 is used to check the distance from the slide to the TIP. If the distance is too short, the TIP could damage the slide, or the drop could adhere to the side of the TIP and not be dispensed on the slide. If the distance is too long, the drop might not be dispensed on the center of the slide. This tool is also used with the *DT60 ANALYZER*. The adjustment procedure has more information about using this tool.

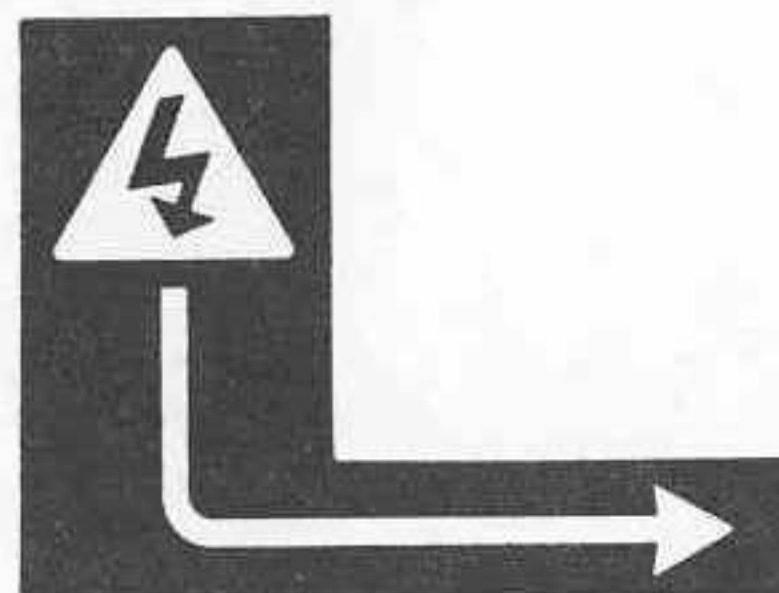
WARNING - DANGEROUS VOLTAGE

Located on TRACK ASSEMBLY
under the FLASH LAMP COVER
PLATE.

Indicates BASE of FLASH LAMP.

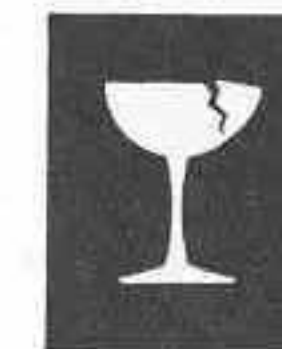
CAUTION LABEL - FRAGILE

Located on READ ARM COVER.

Indicates damage to SAPPHIRE
WINDOW if READ ARM falls.

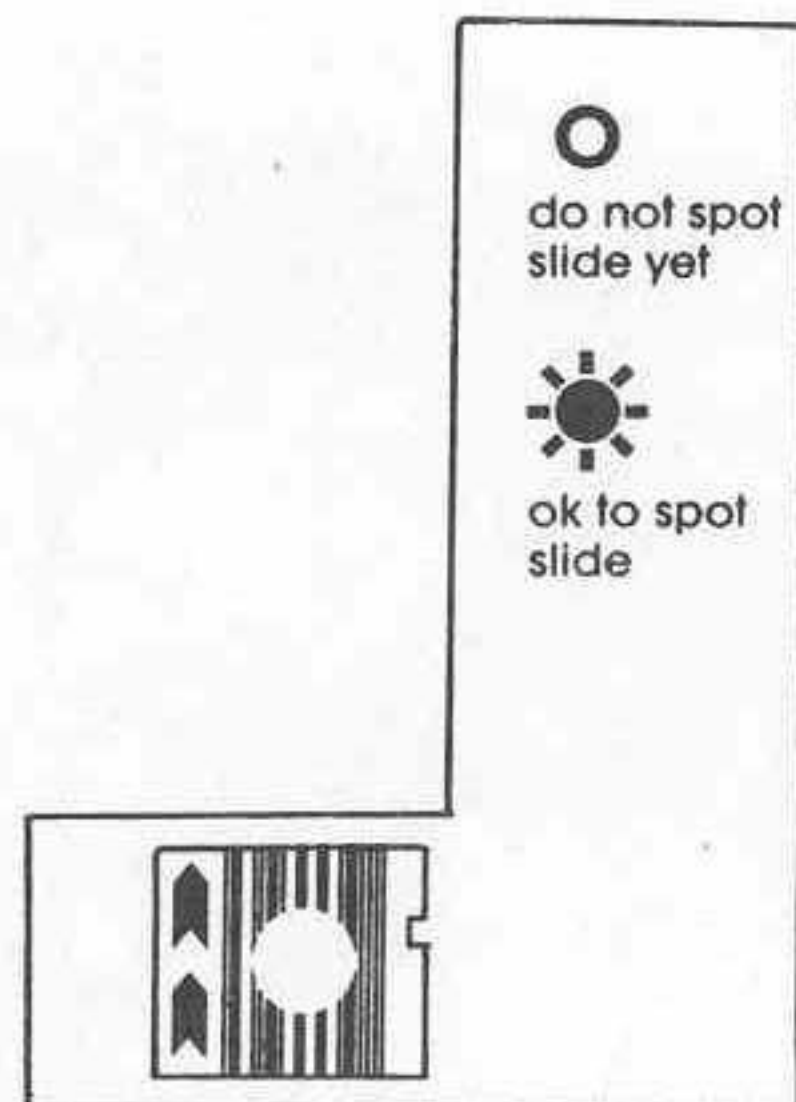
TRACK LABEL

Located on TRACK ASSEMBLY.

Indicates correct slide position
and spotting indication.

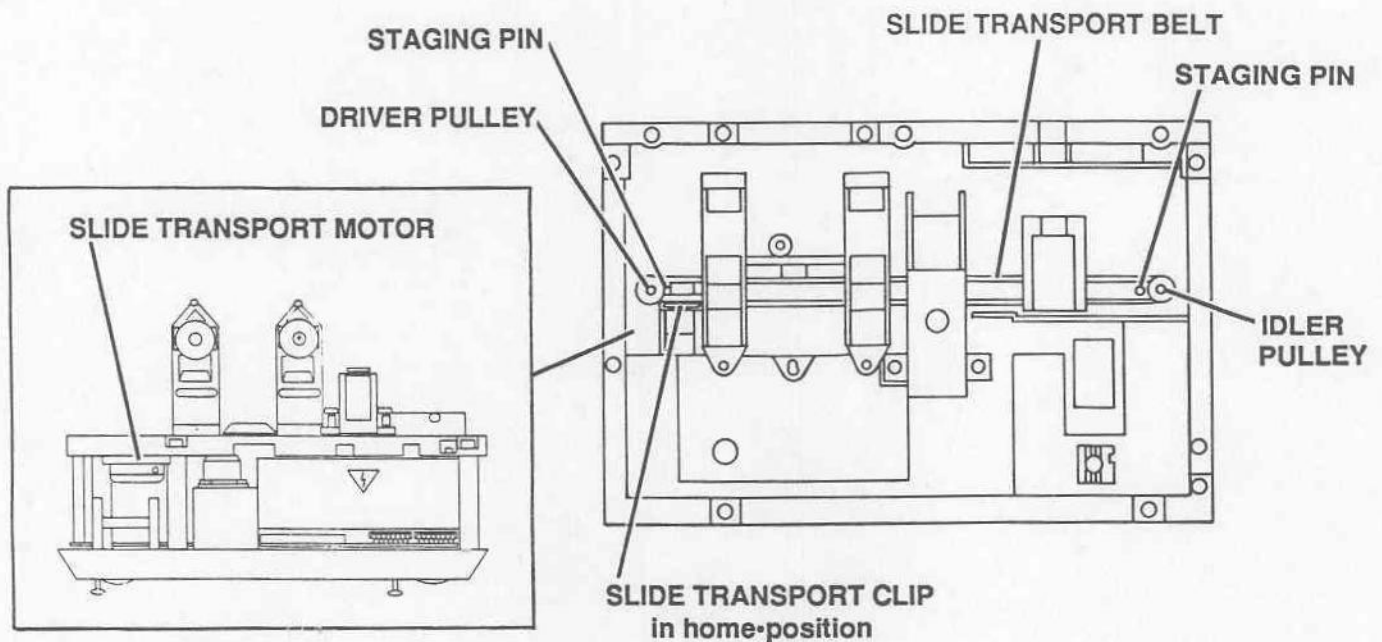
SLIDE TRANSPORT TRACKS

The slide moves within plastic and metal surfaces, the SLIDE TRANSPORT TRACKS. The metal component is a separate part, the PREHEAT PLATEN ASSEMBLY. Heating devices below the PREHEAT PLATEN ASSEMBLY and in the READ ARM and PREHEAT ARM keep the slides at a monitored temperature of 37.0° C (98.6° F.)

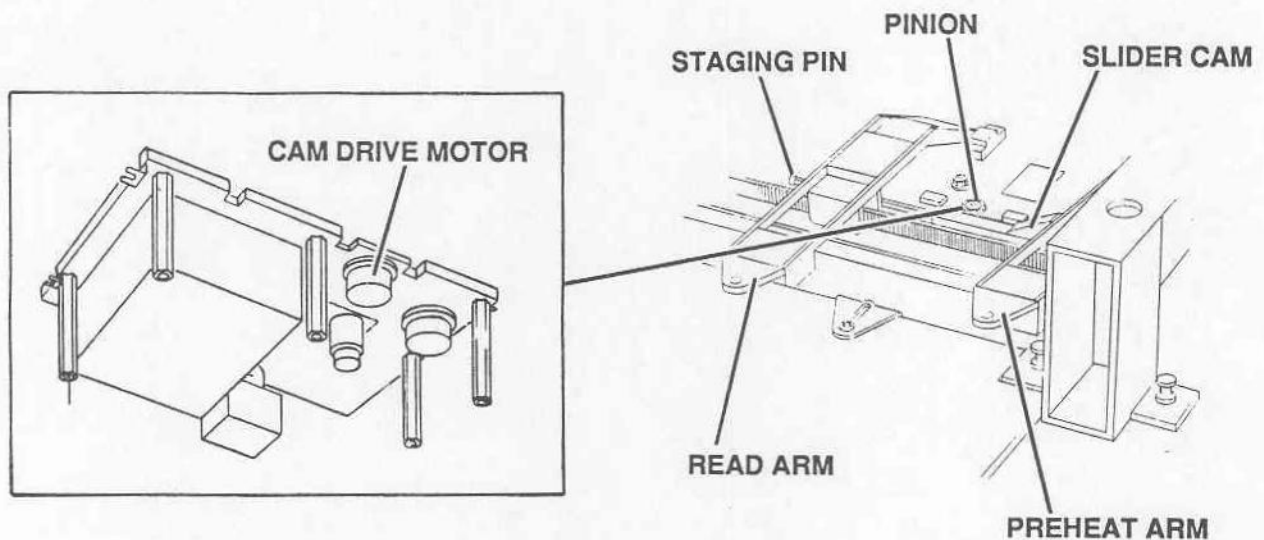
The ANALOG BOARD receives data from and transfers signals to almost all of the operating components in the DTSC MODULE. To operate the Slide Transport System, the ANALOG BOARD has DRIVER INTEGRATED CIRCUITS that operate the SLIDE TRANSPORT MOTOR and the CAM DRIVE MOTOR. DRIVER INTEGRATED CIRCUIT U7 sends step counts to the SLIDE TRANSPORT MOTOR. DRIVER INTEGRATED CIRCUIT U1 sends step counts to the CAM DRIVE MOTOR. The following figure gives the CONNECTORS that provide data communication with the components described in this section.

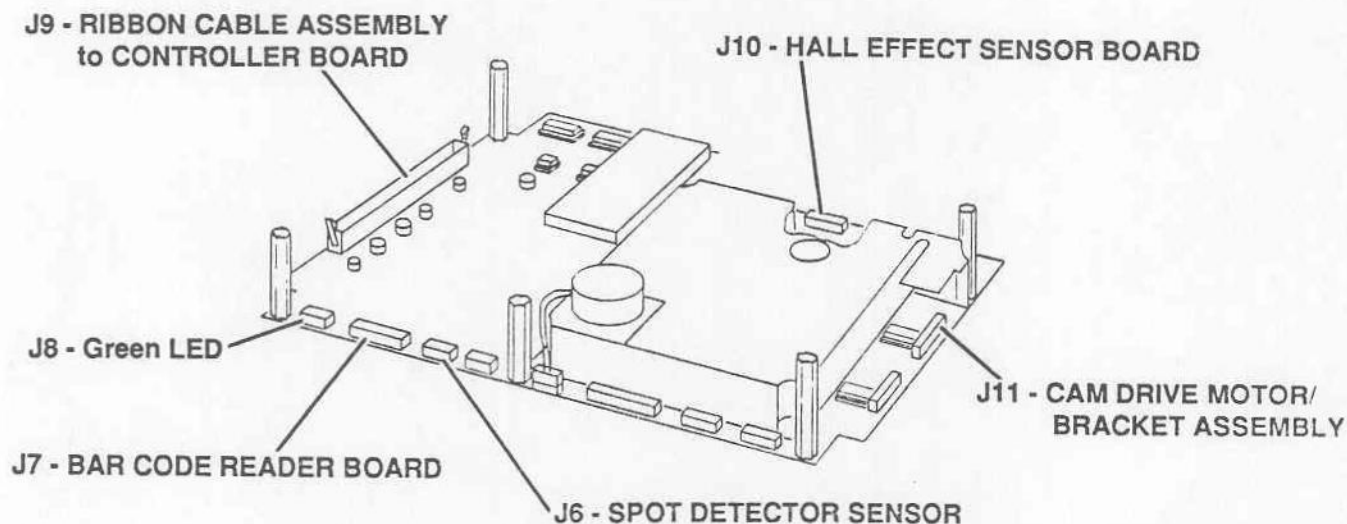
CONNECTOR J9 on the ANALOG BOARD transfers data from the SENSORS to the CONTROLLER BOARD. Then the CONTROLLER BOARD executes command signals to the ANALOG BOARD that indicate the correct times to operate the SLIDE TRANSPORT MOTOR and the CAM DRIVE MOTOR. A RIBBON CABLE which is permanently attached to CONNECTOR J3 provides data communication with the ANALOG BOARD. CONNECTOR J1 on the CONTROLLER BOARD provides data communication with the computers in the DT60 ANALYZER.

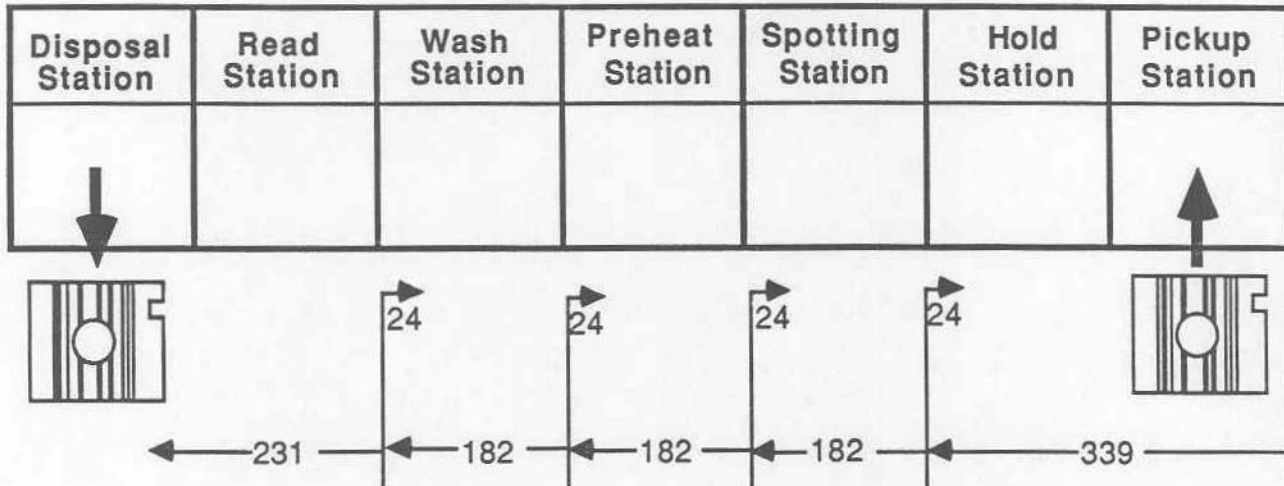
Step Count Diagram

The following figure indicates the complete motion of the SLIDE TRANSPORT CLIP. The numbers indicate an approximate number of steps the SLIDE TRANSPORT MOTOR moves the SLIDE TRANSPORT CLIP for each station.

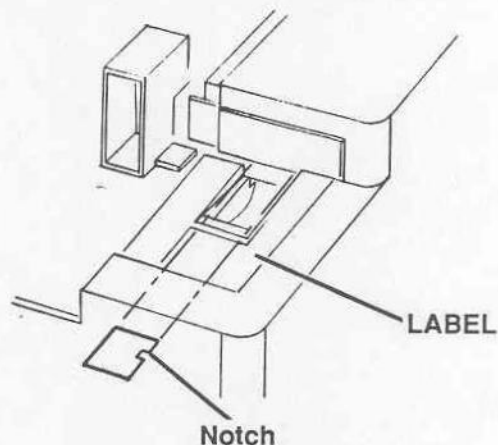
1. Slides are inserted manually at the Pickup Station. The slides are inserted with the bar code up, and the notch toward the right. The LABEL adjacent to the Pickup Station indicates the correct position for inserting slides.

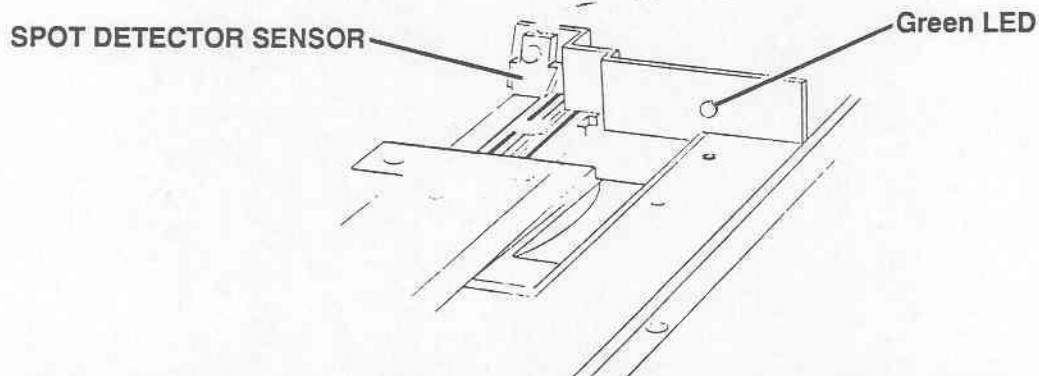
14. The white surface of the slide causes the SPOT DETECTOR SENSOR to detect a change in reflectance. After 3 seconds, the message "SPOT SLIDE WITH FLUID" is displayed. The 3 second delay allows the SPOT DETECTOR SENSOR to stabilize. The green LED flashes and a tone occurs to indicate to the operator that the slide is ready for sample fluid.

15. The SPOT DETECTOR SENSOR monitors the reflectance of the slide. When fluid is dispensed on the slide, the reflectance is reduced. This change causes the SPOT DETECTOR SENSOR to execute a signal to the ANALOG BOARD.

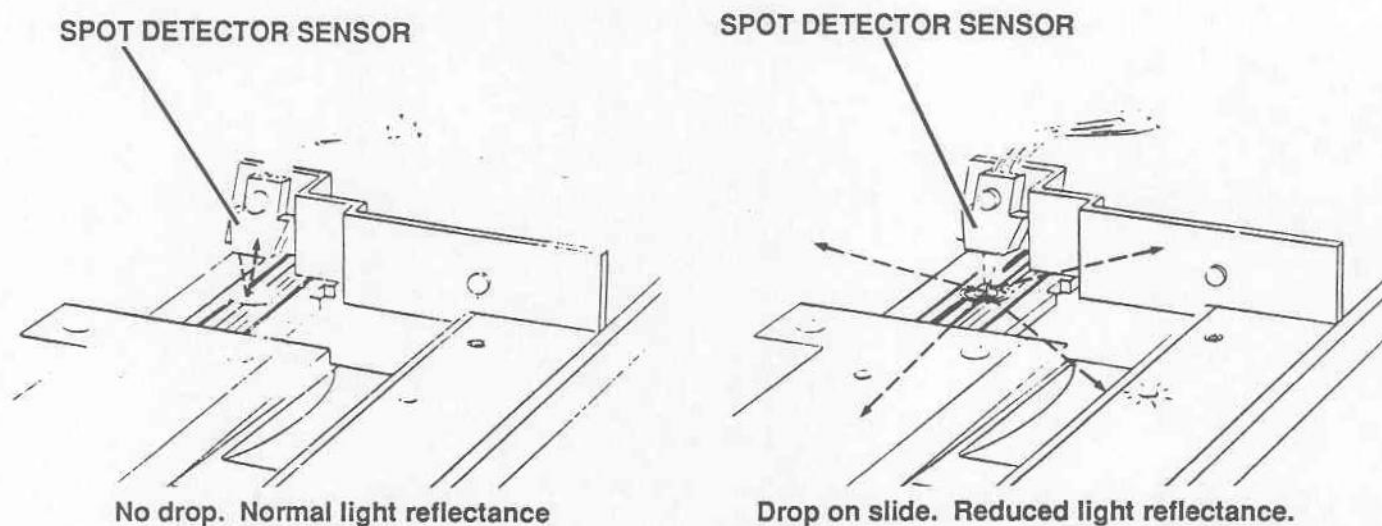
16. The green LED stops flashing, and the message "WAIT - SLIDE BEING LOADED" is displayed. The CONTROLLER BOARD executes a signal for the SLIDE TRANSPORT MOTOR that causes motion of the slide to the Preheat Station.
17. At the same time, the CAM DRIVE MOTOR is energized. The SLIDER CAM moves from home position to the right, lifting the PREHEAT ARM to allow the slide to move below it.

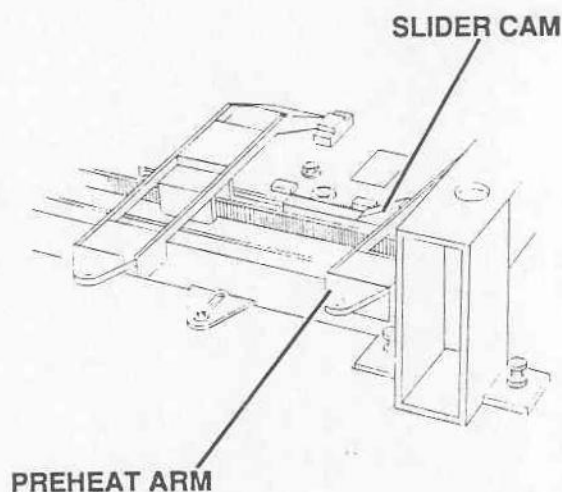
18. The slide advances a short distance beyond the Preheat Station, and then the direction of the SLIDE TRANSPORT MOTOR reverses, causing the slide to move backward against the STAGING RAMP. The motion is controlled only by the step count to the SLIDE TRANSPORT MOTOR, and there is no device to detect that the slide is in the Preheat Station.

19. The CAM DRIVE MOTOR moves the SLIDER CAM to the left, causing the PREHEAT ARM to move down over the slide. The CLIP DETENT on the PREHEAT ARM compresses the CLIP and raises it from the slide.
